UNITED STATES ENVIRONMENTAL PROTECTION AGENCY

SUBJECT: Immediate Removal Request for the Shaffer
Equipment Site, Fayette County, Minden,
West Virginia

FROM: Robert E. Caron, On-Scene Coordinator
Emergency Response Section (3HW22)

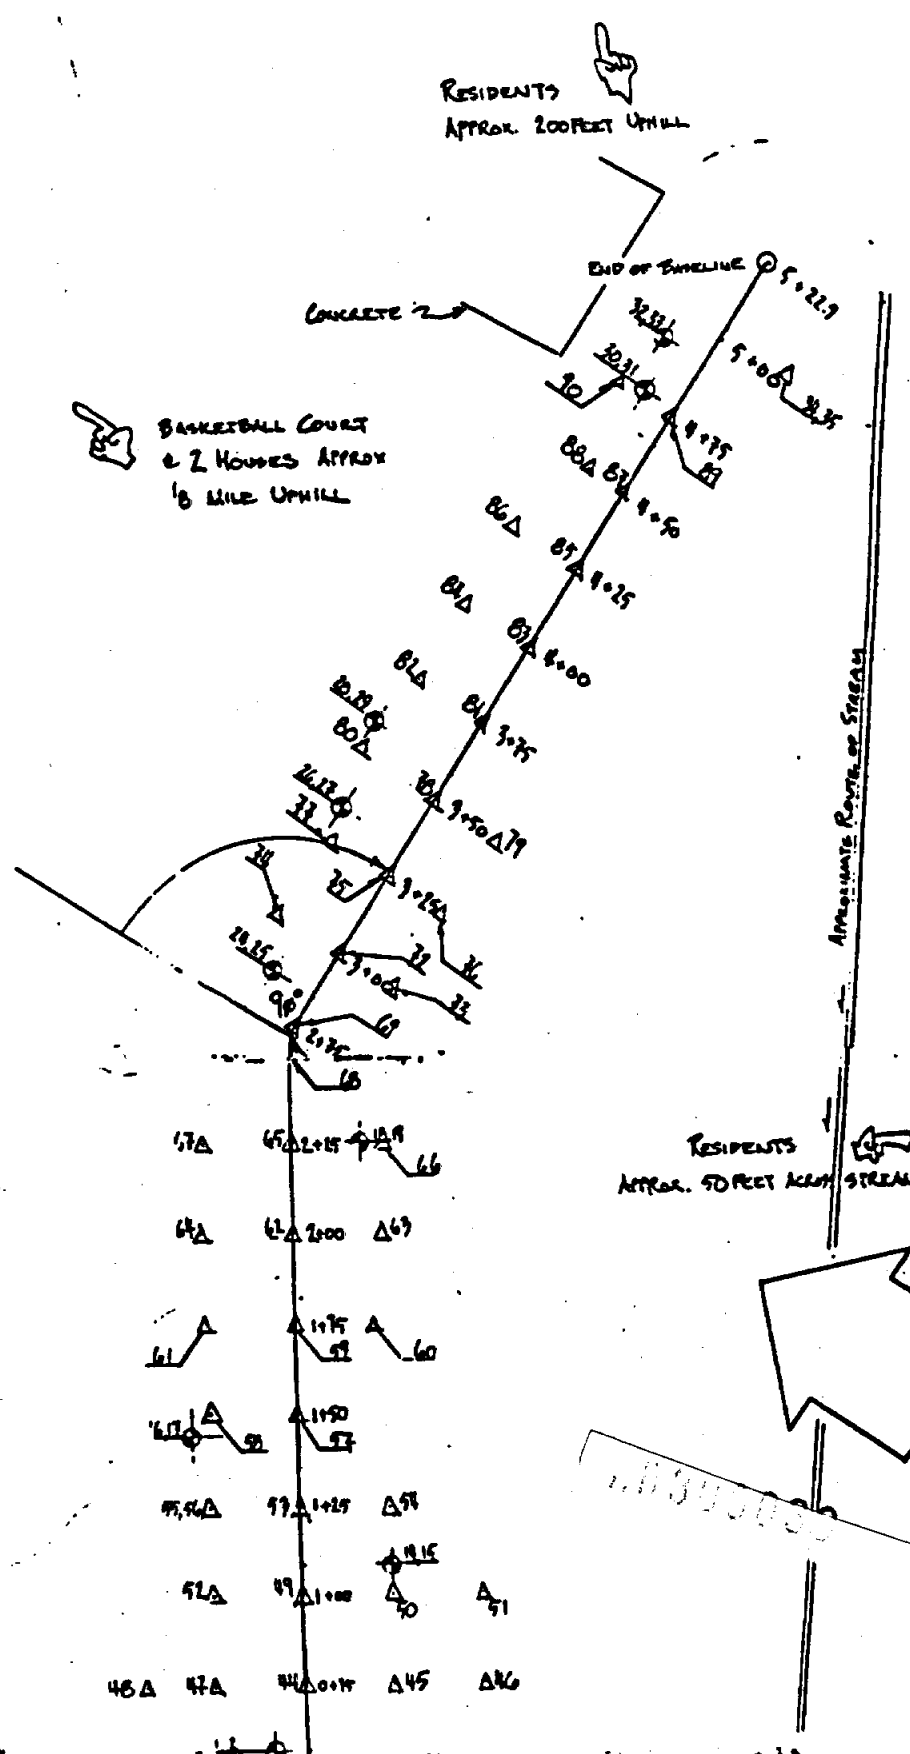
POTENTIAL HOT
 SPOT 10/3/04
 ASSESSMENT NOTED:
 7 TRANSFORMERS
 29 CAPACITORS
 27 55-gal DRUMS
 HOWEVER WAS NOT SAMPLED
 - 11/2/04 DUE TO
 INACCESSIBILITY

SHAFFER ELECTRIC	
EXTENT OF CONTAMINATION (SURFACE)	
DRUGS	11/2/04 TATS
